ServiceCam live gas CCTV system prevents need to excavate and mole 20 meter long driveway by identifying poor pressure problem, saving £1,000

- Detached house on Richmond Road, Wolverhampton
- Poor pressure has caused the customers boiler to cut out several times—requiring call outs
- Service type is 1" metallic lined with 20m PE
- Suspected Tee connecting to adjacent property
- Works carried out in November 2015
- Client is National Grid Gas Distribution
- Approved ServiceCam live gas CCTV system for services used by single operative
- Estimated savings £1,000 by avoiding excavations and use of Mole

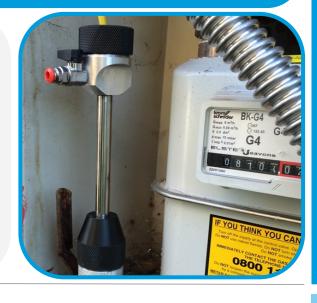
- Access to the service as made through the ECV under live gas conditions
- The ServiceCam pushed through the 20mm PE lined 1" metallic service up to 20meters
- No Tee was located—the service was connected to the parent main in the road
- A single excavation can now be dug outside of the customers property boundaries to resolve the issue of over insertion of 20mm PE
