# Case Study — ServiceCam 01

Gas Distribution Network saves £1,000 on a single job, reducing excavations & avoiding 20m mole, using ServiceCam to quickly identify cause of poor pressure.

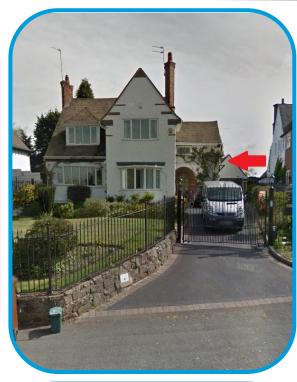
- Large detached house with 20m long block paved & tarmacked driveway.
- Homeowner's boiler having repeated cutouts due to low gas supply pressure, requiring multiple call outs.
- Service is 1" metallic, lined with 20mm PE.
- Gas Distribution Network suspected that the service might include a Tee feeding the adjacent property.
- Approved ServiceCam live gas CCTV system for services, single operative use.
- Estimated savings £1,000 by reducing excavations & avoiding 20m mole.
- Works carried out in November 2015.

- Access to the service made through the ECV under live gas conditions.
- ServiceCam pushed along the 20mm PE lined 1" metallic service to its maximum distance of 20m.
- No Tee was located, the service was connected directly to the parent main in the roadway.
- Cause was over insertion of 20mm PE, resolved by digging a single excavation outside of the property boundary.
