## Case Study — Water Extraction Mains 01

Gas Distribution Network solves historic water ingress problem using Synthotech's latest Water Extraction System for live gas mains.

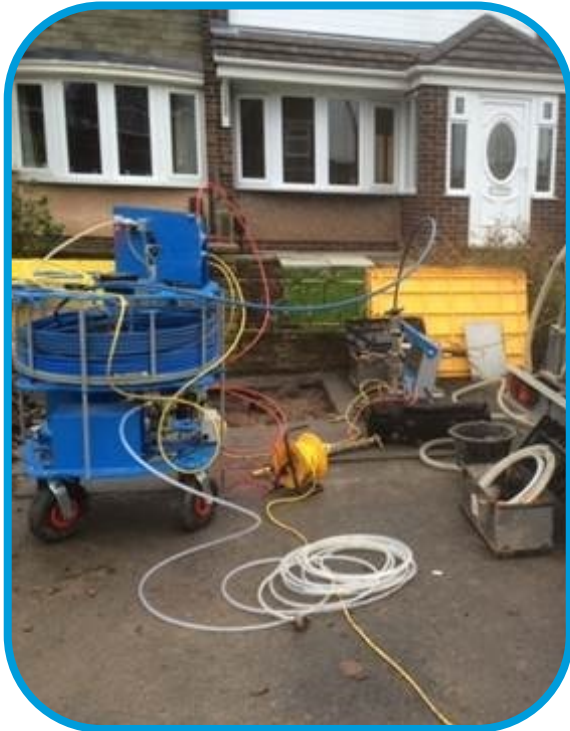
- 4" main in residential area, one property repeatedly going off gas due to water being drawn up through the service.
- 88 repeat visits by Gas Distribution Network since 2013, to remove water from syphon point.
- Syphon point only collecting water from low point, hence cause & location of leak not identified.
- New Synthotech Water Extraction System removed water along the main (not just the syphon point), then correctly identified cause & location of leakage.
- Estimated savings over £10,000.
- Works carried out in December 2015.

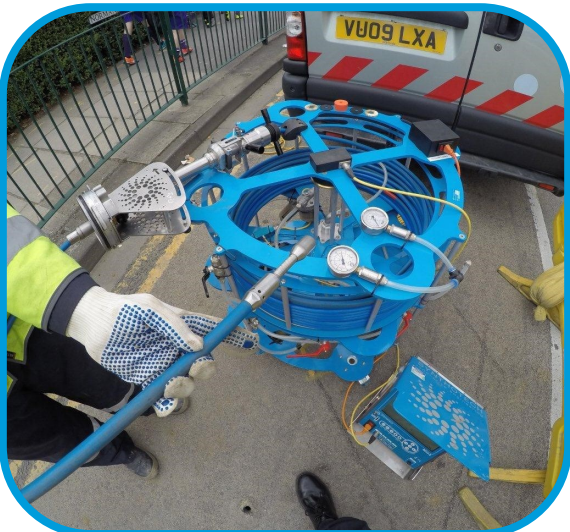
- Access to the main via standard drilling system, under live gas conditions.
- System surveyed the along main, removing water throughout & then discovered signs of fracture towards the bottom of the main.
- Once all water removed, the main was left overnight.
- Subsequent survey next day confirmed water ingress via fracture on lower part of the main. Clip fitted and no further issues reported (Jan 2016).

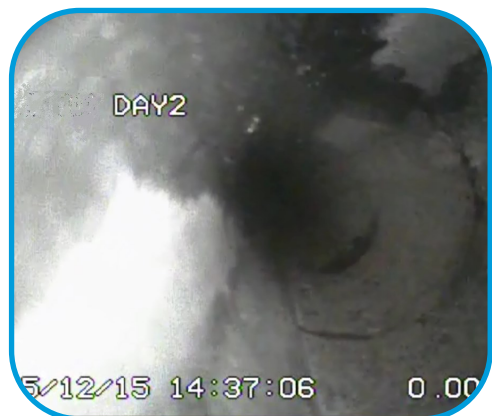
- The key to success was being able to continuously extract water whilst carrying out the CCTV survey, all under live gas conditions.
- The combination of removing water from localised areas enabled the CCTV to identify potential cause of water ingress.
- The fracture was below the level of water, hence localised water extraction essential to find the cause of ingress.
