Success as ServiceCam locates an ongoing gas escape and saves National Grid over £1000

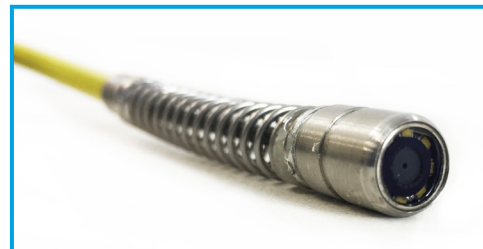
- Live Gas CCTV Survey Systems for pre-enabling, investigation of poor pressure, water ingress or installation issues.
- 1"metallic/17.5mm-32mm PE and Serviflex Services.
- Entry via 3/4"-1" ECV- no need for drilling.
- Up to 20m push distance with a 6mm cobra.
- For pressures up to 75mbar.
- 9.5mm LED camera for long lasting bright vision.
- Handheld display unit that last for up to 5 hours use, rechargeable from mains or 12v in-car.

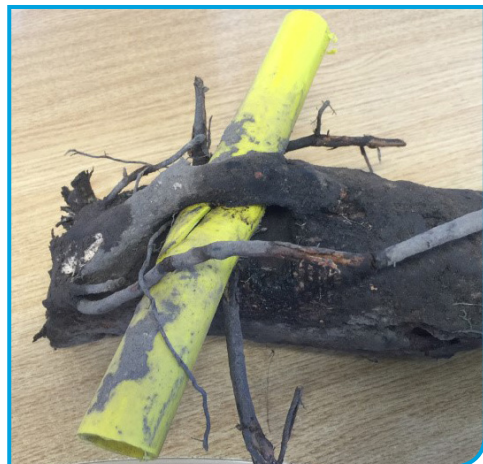
- Using Servicecam the team were able to find that the PE pipe had been damaged by a tree root that had wrapped itself around the service. After accurately locating the problem the team were able to precisely excavate and carryout repairs in a matter of hours **saving time and over £1000.**
- Simple to use and simple to train.
- One man operation.
