Case Study — Synthocam 01

18" steel pipeline at Above Ground Installation needing inspection—the latest Synthocam CCTV system helps with investigation, minimising asset intervention.

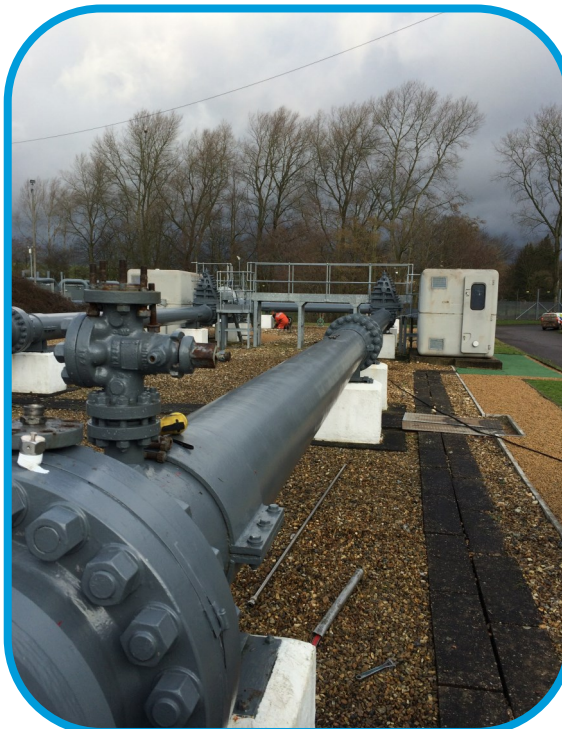
- 18" steel pipeline at large High Pressure Above Ground Installation (AGI).
- Previous high gas velocity incident had caused damage to one of the filters.
- Suspected that debris from the damaged filter had travelled into other sections of the AGI pipework.
- Synthotech carried out a Specialist Service on site to insert a camera into the pipeline & inspect for debris.
- No debris found in the areas surveyed, hence likely that debris is located in a below-ground low point.
- Works carried out in January 2016.

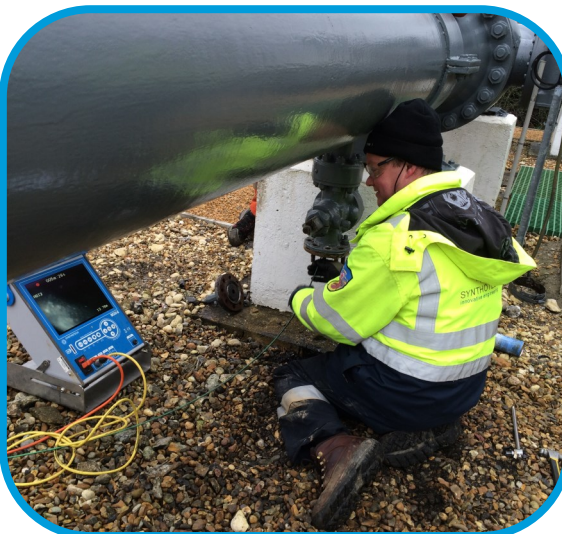
- Access to the pipeline via 2" vent / purge / drain tapered plug valves.
- Bespoke insertion tube was designed, manufactured & tested by Synthotech specifically to ensure that the camera could gain entry to the pipeline via the tapered plug valves.
- Surveyed the along pipeline, checking for debris & recording the CCTV footage.
- Further survey of the below-ground pipeline sections planned for summer 2016.

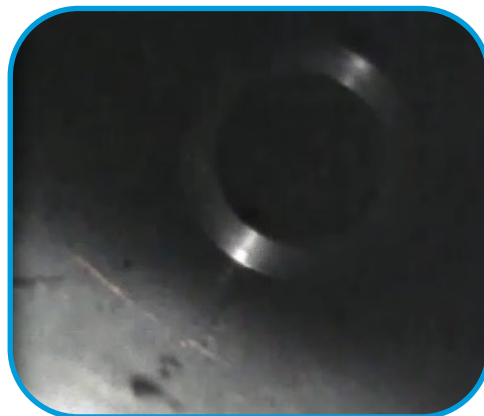
- The Synthocam system is fully approved by all UK gas networks, across a range of pressures.
- The challenge with this survey was to ensure that the camera could safely enter the pipeline via the small bore of a tapered plug valve.
- Synthotech design & manufacture their systems in-house, & hence were able to quickly make & test a suitable insertion tube.
